FLIGHT MEASUREMENTS OF HORIZONTAL TAIL LOADS ON A
TYPICAL PROPELLER-DRIVEN PURSUIT AIRPLANE DURING
STALLED PULL-OUTS AT HIGH SPEED

By Lawrence A. Clousing and William N. Turner

Ames Aeronautical Laboratory
Moffett Field, California

MEMORANDUM REPORT

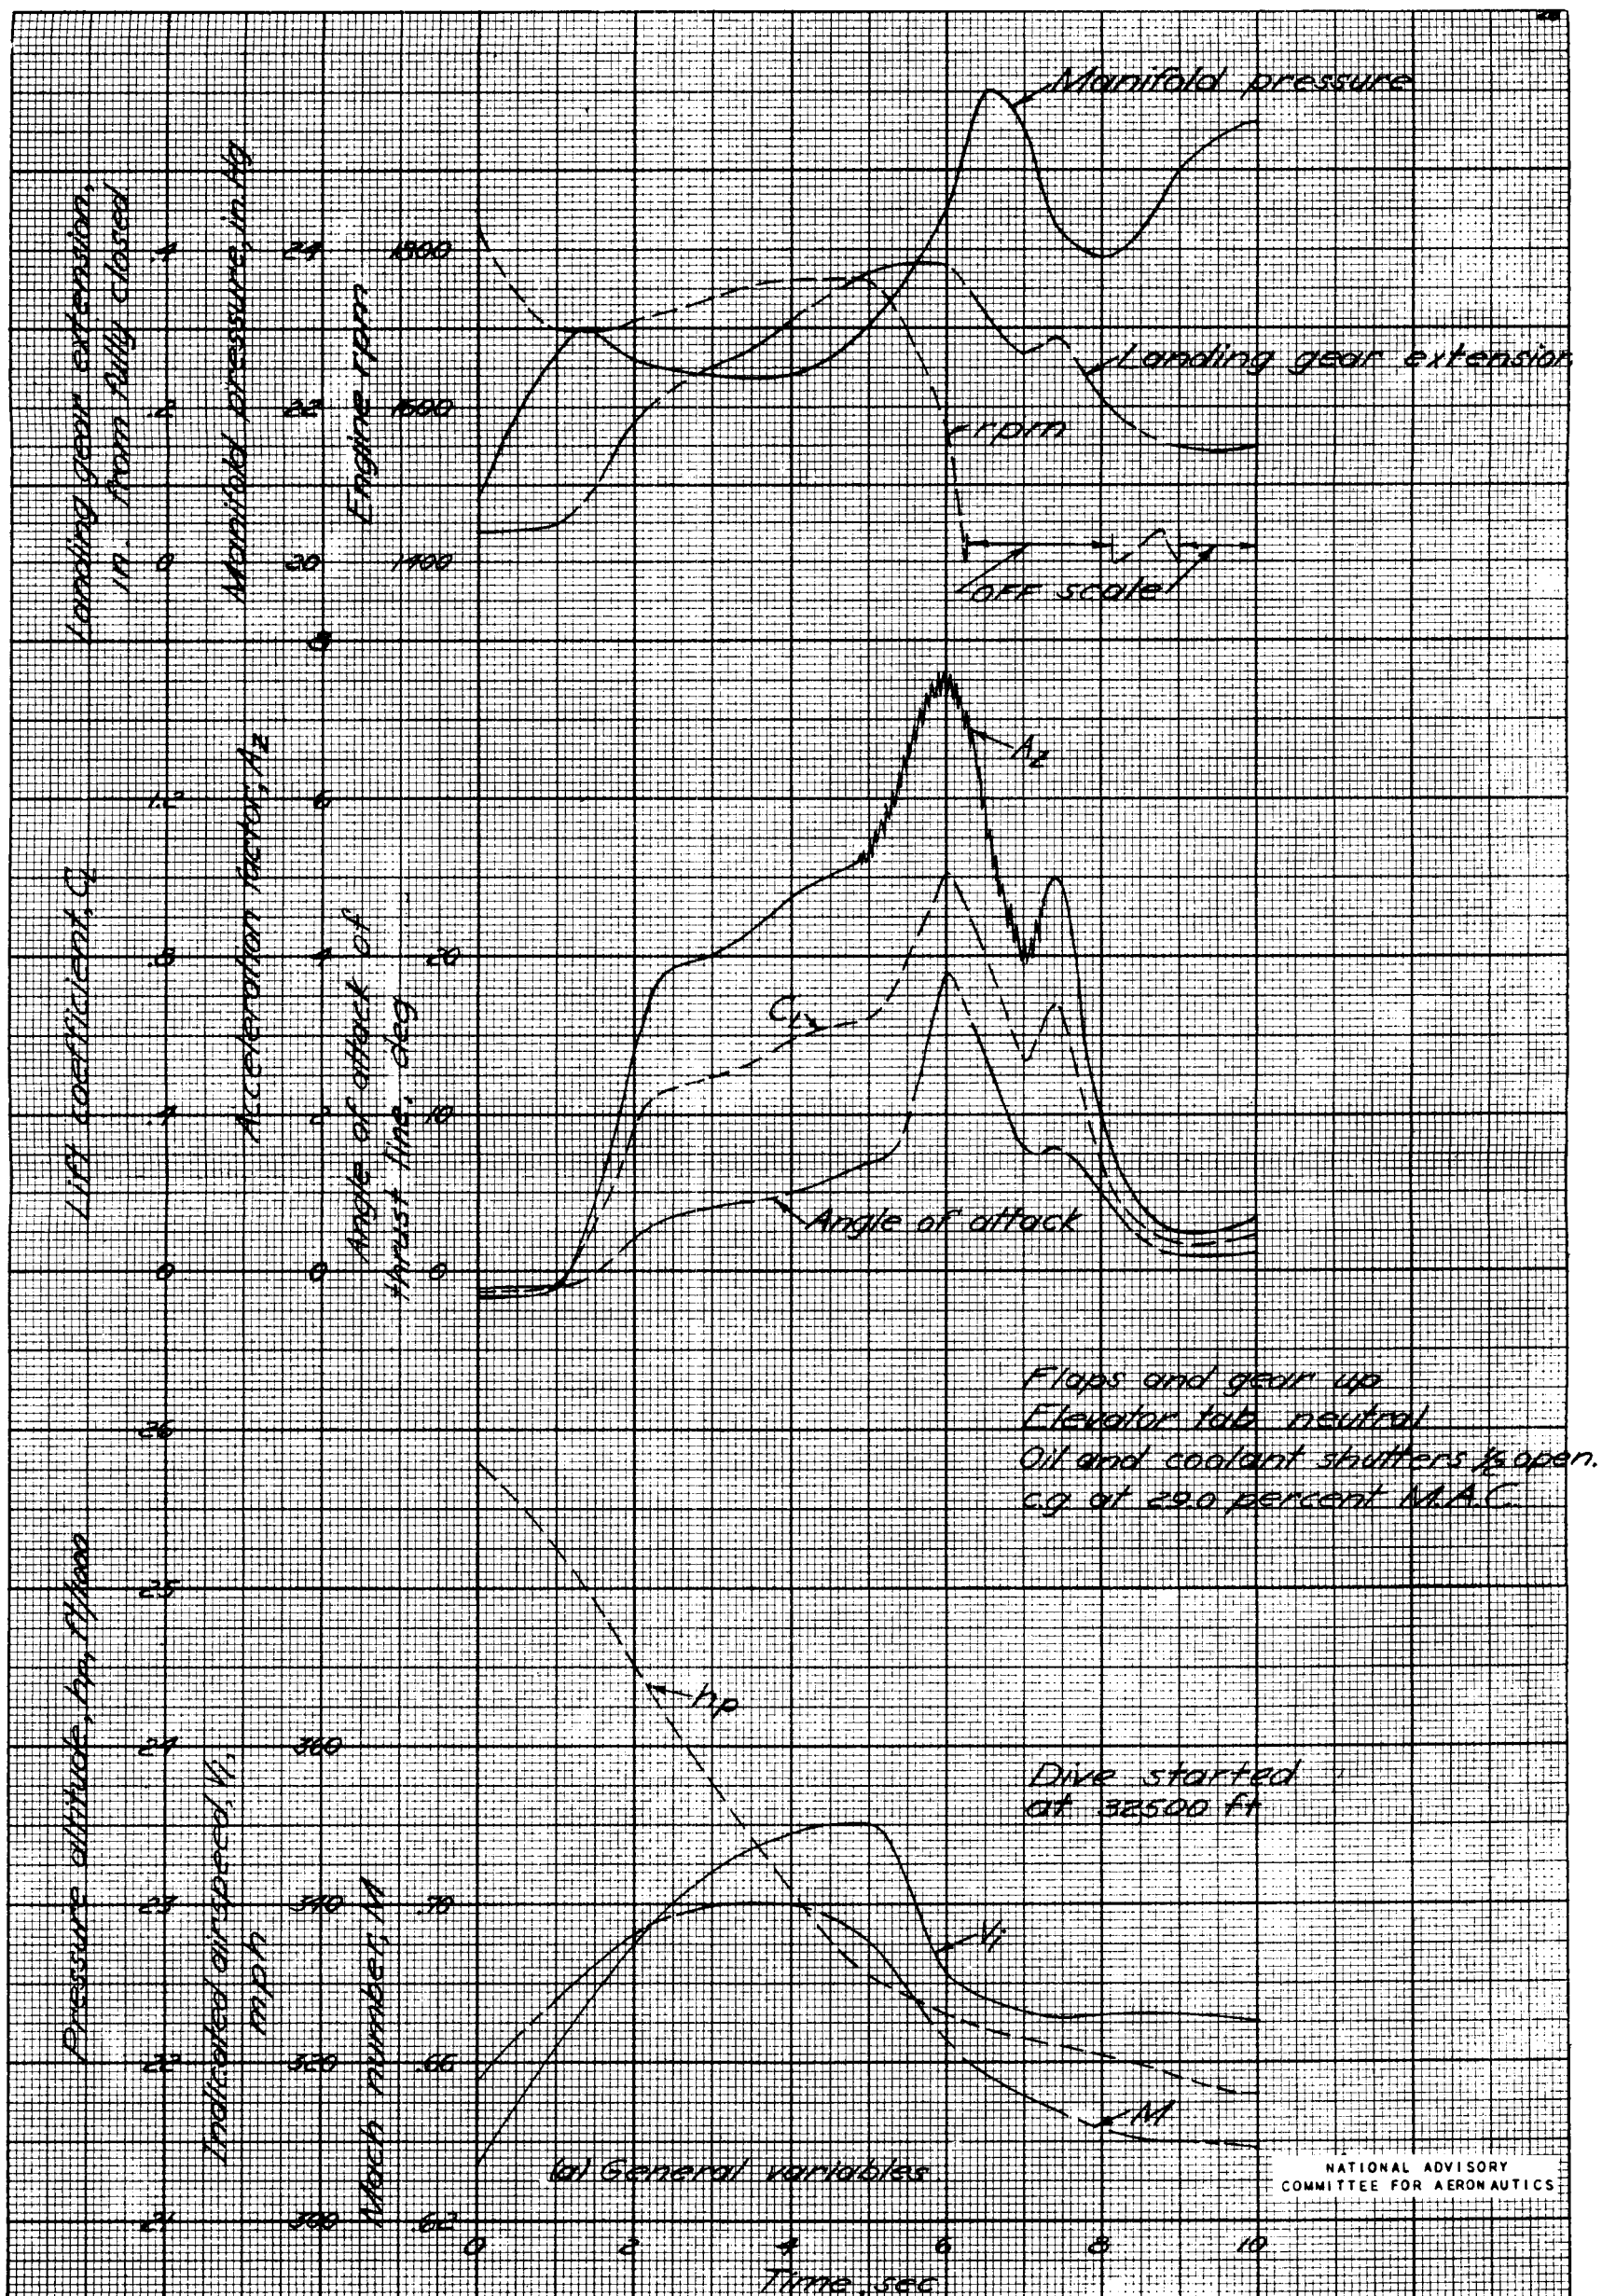
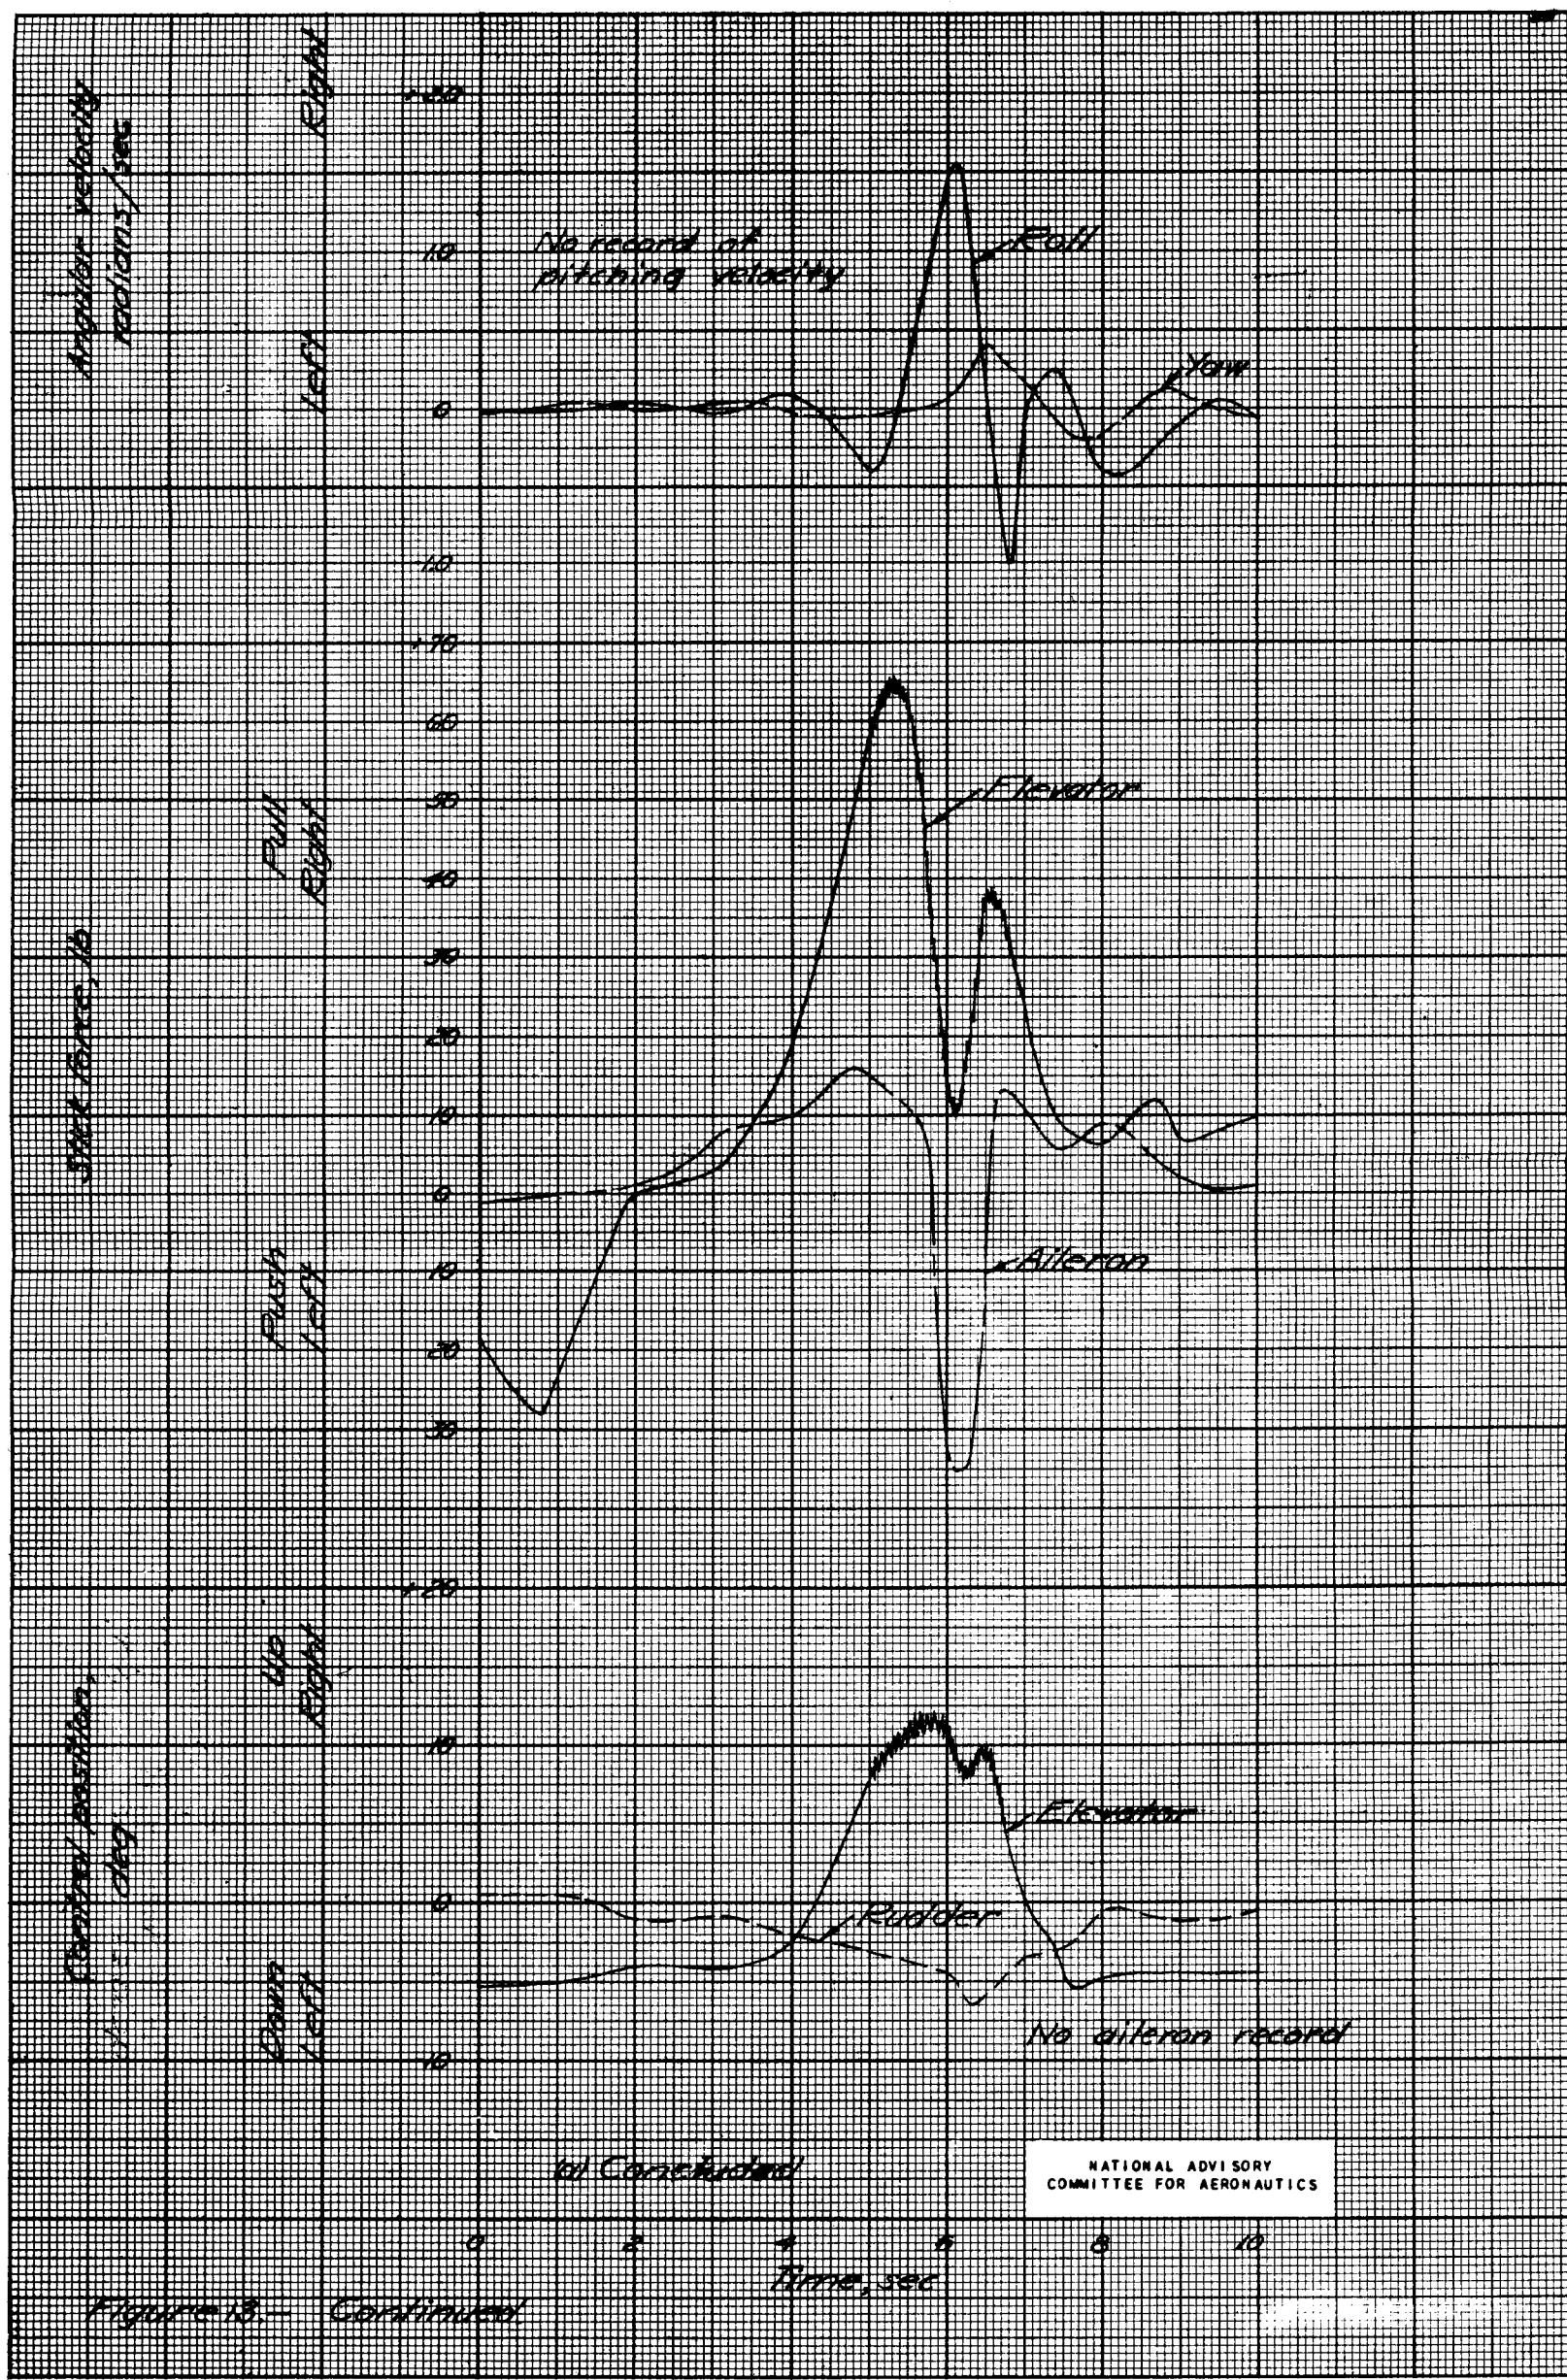
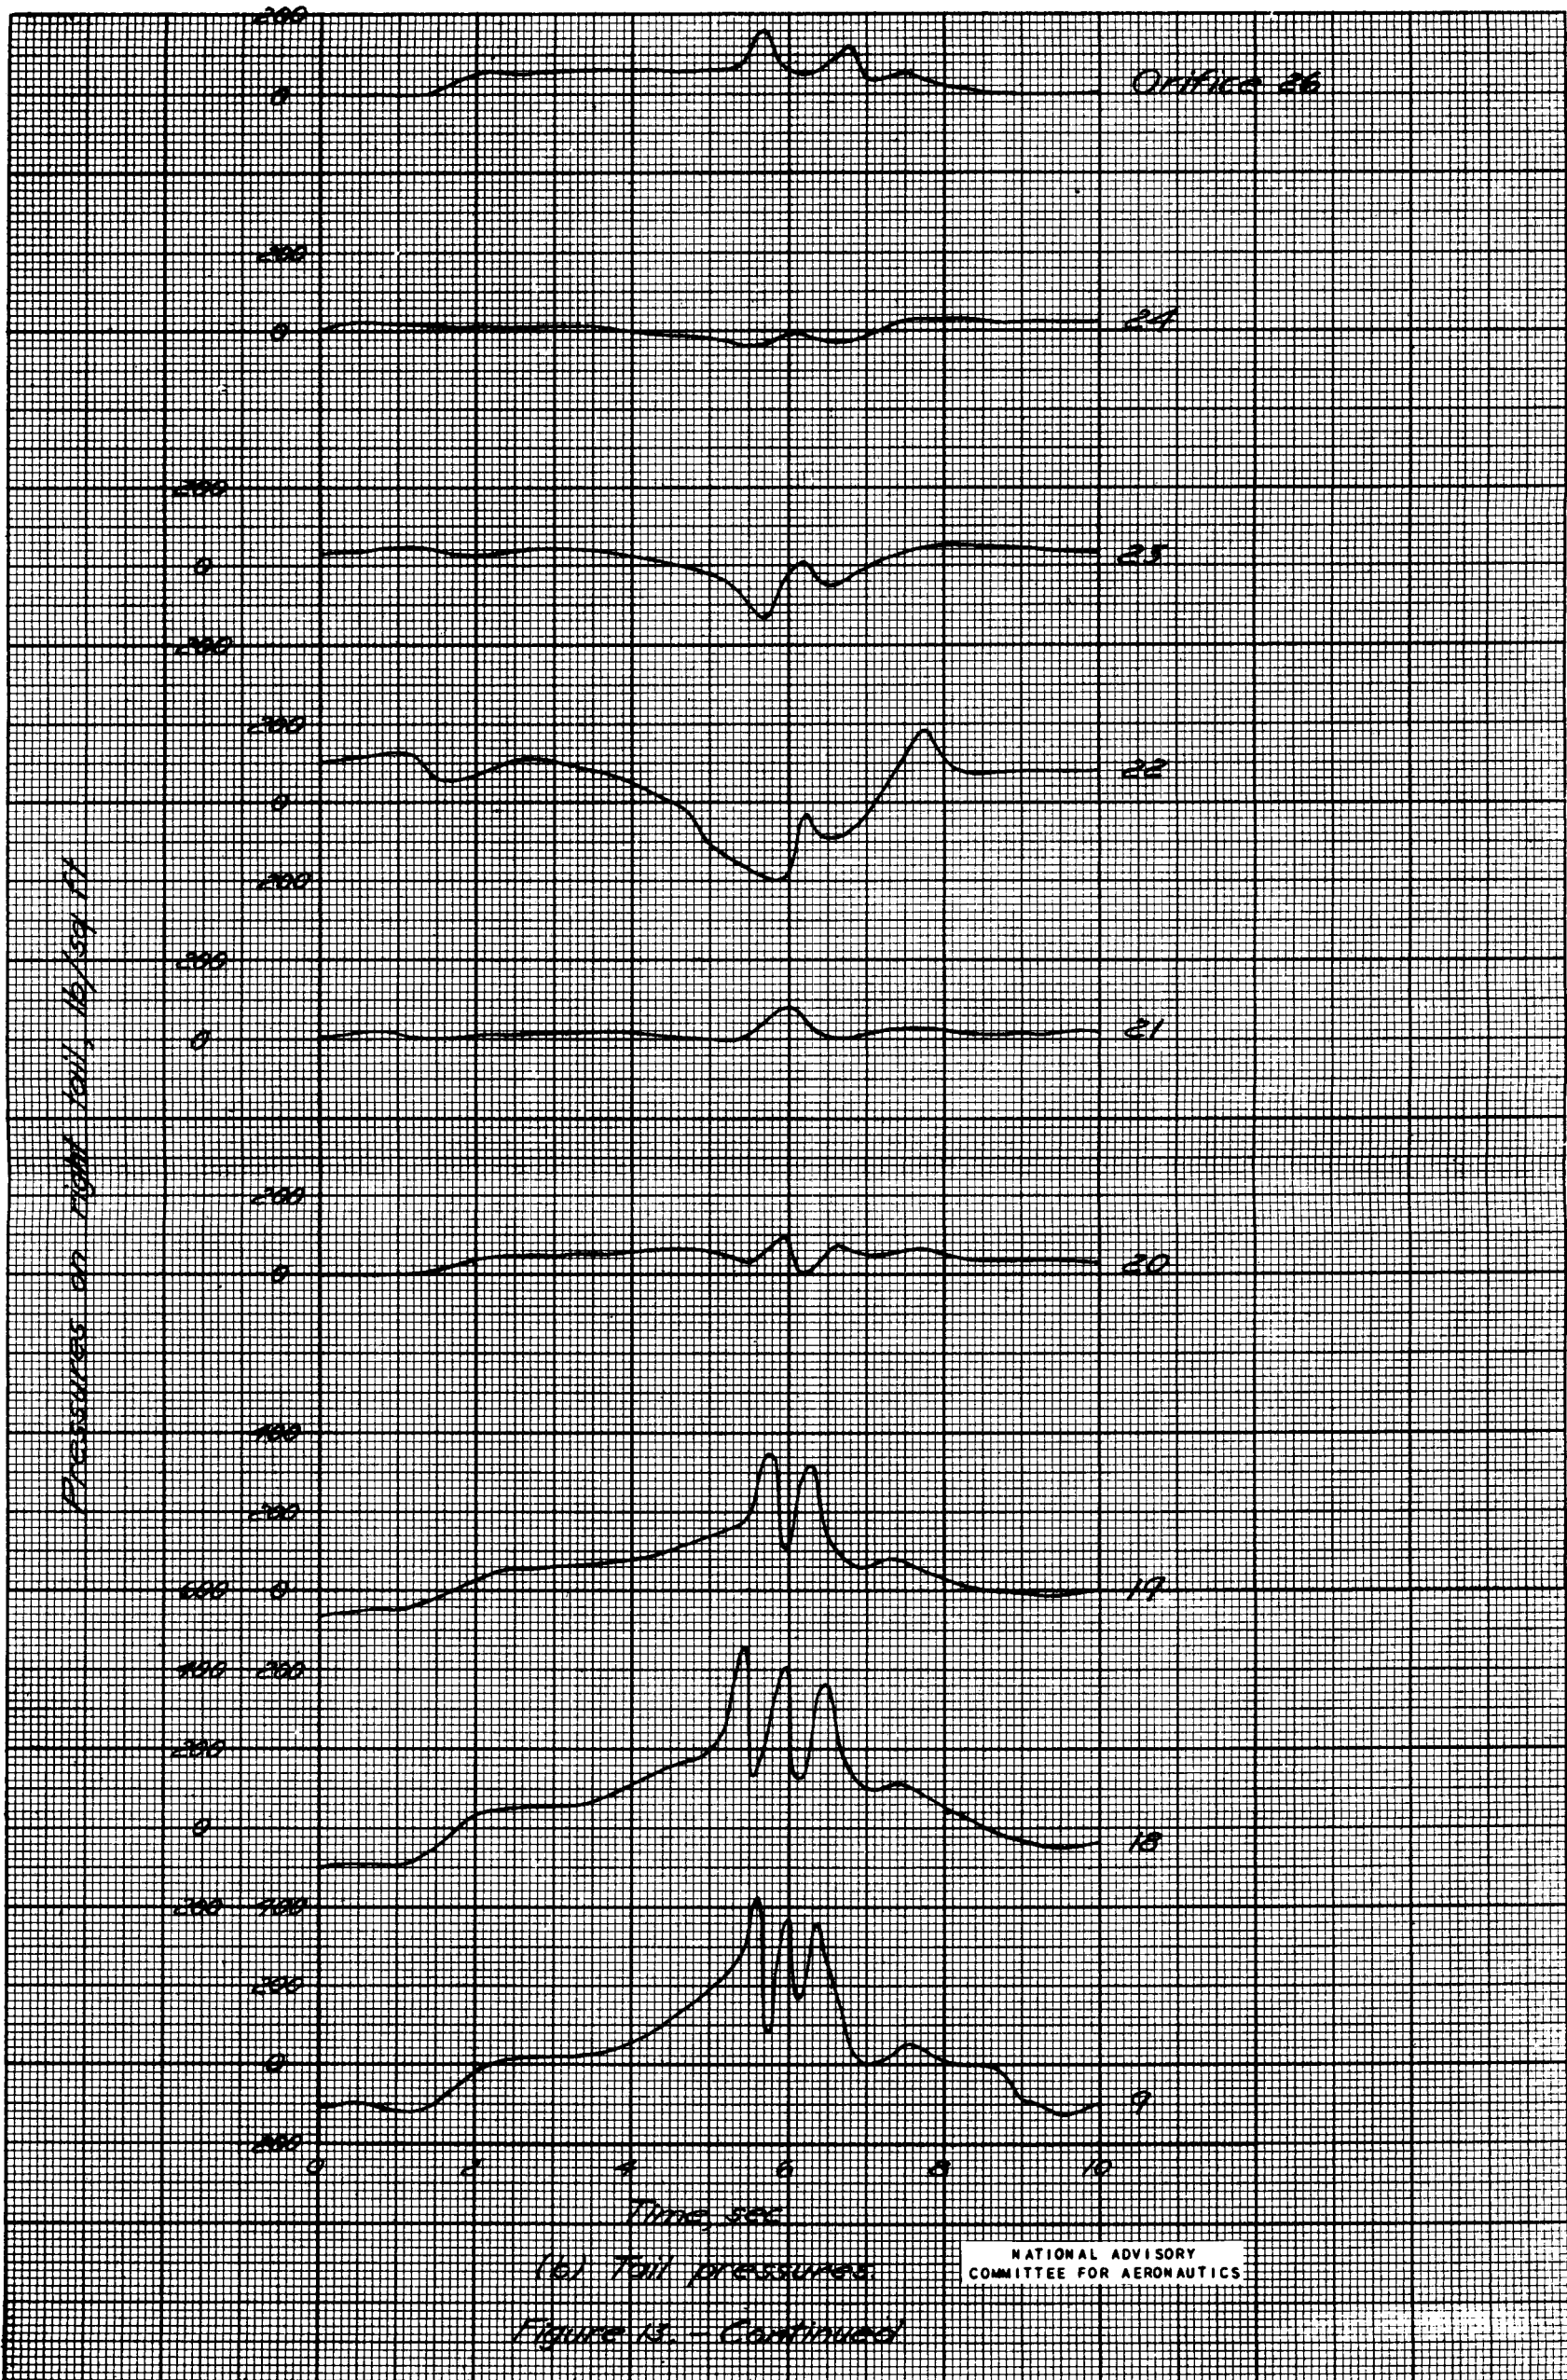
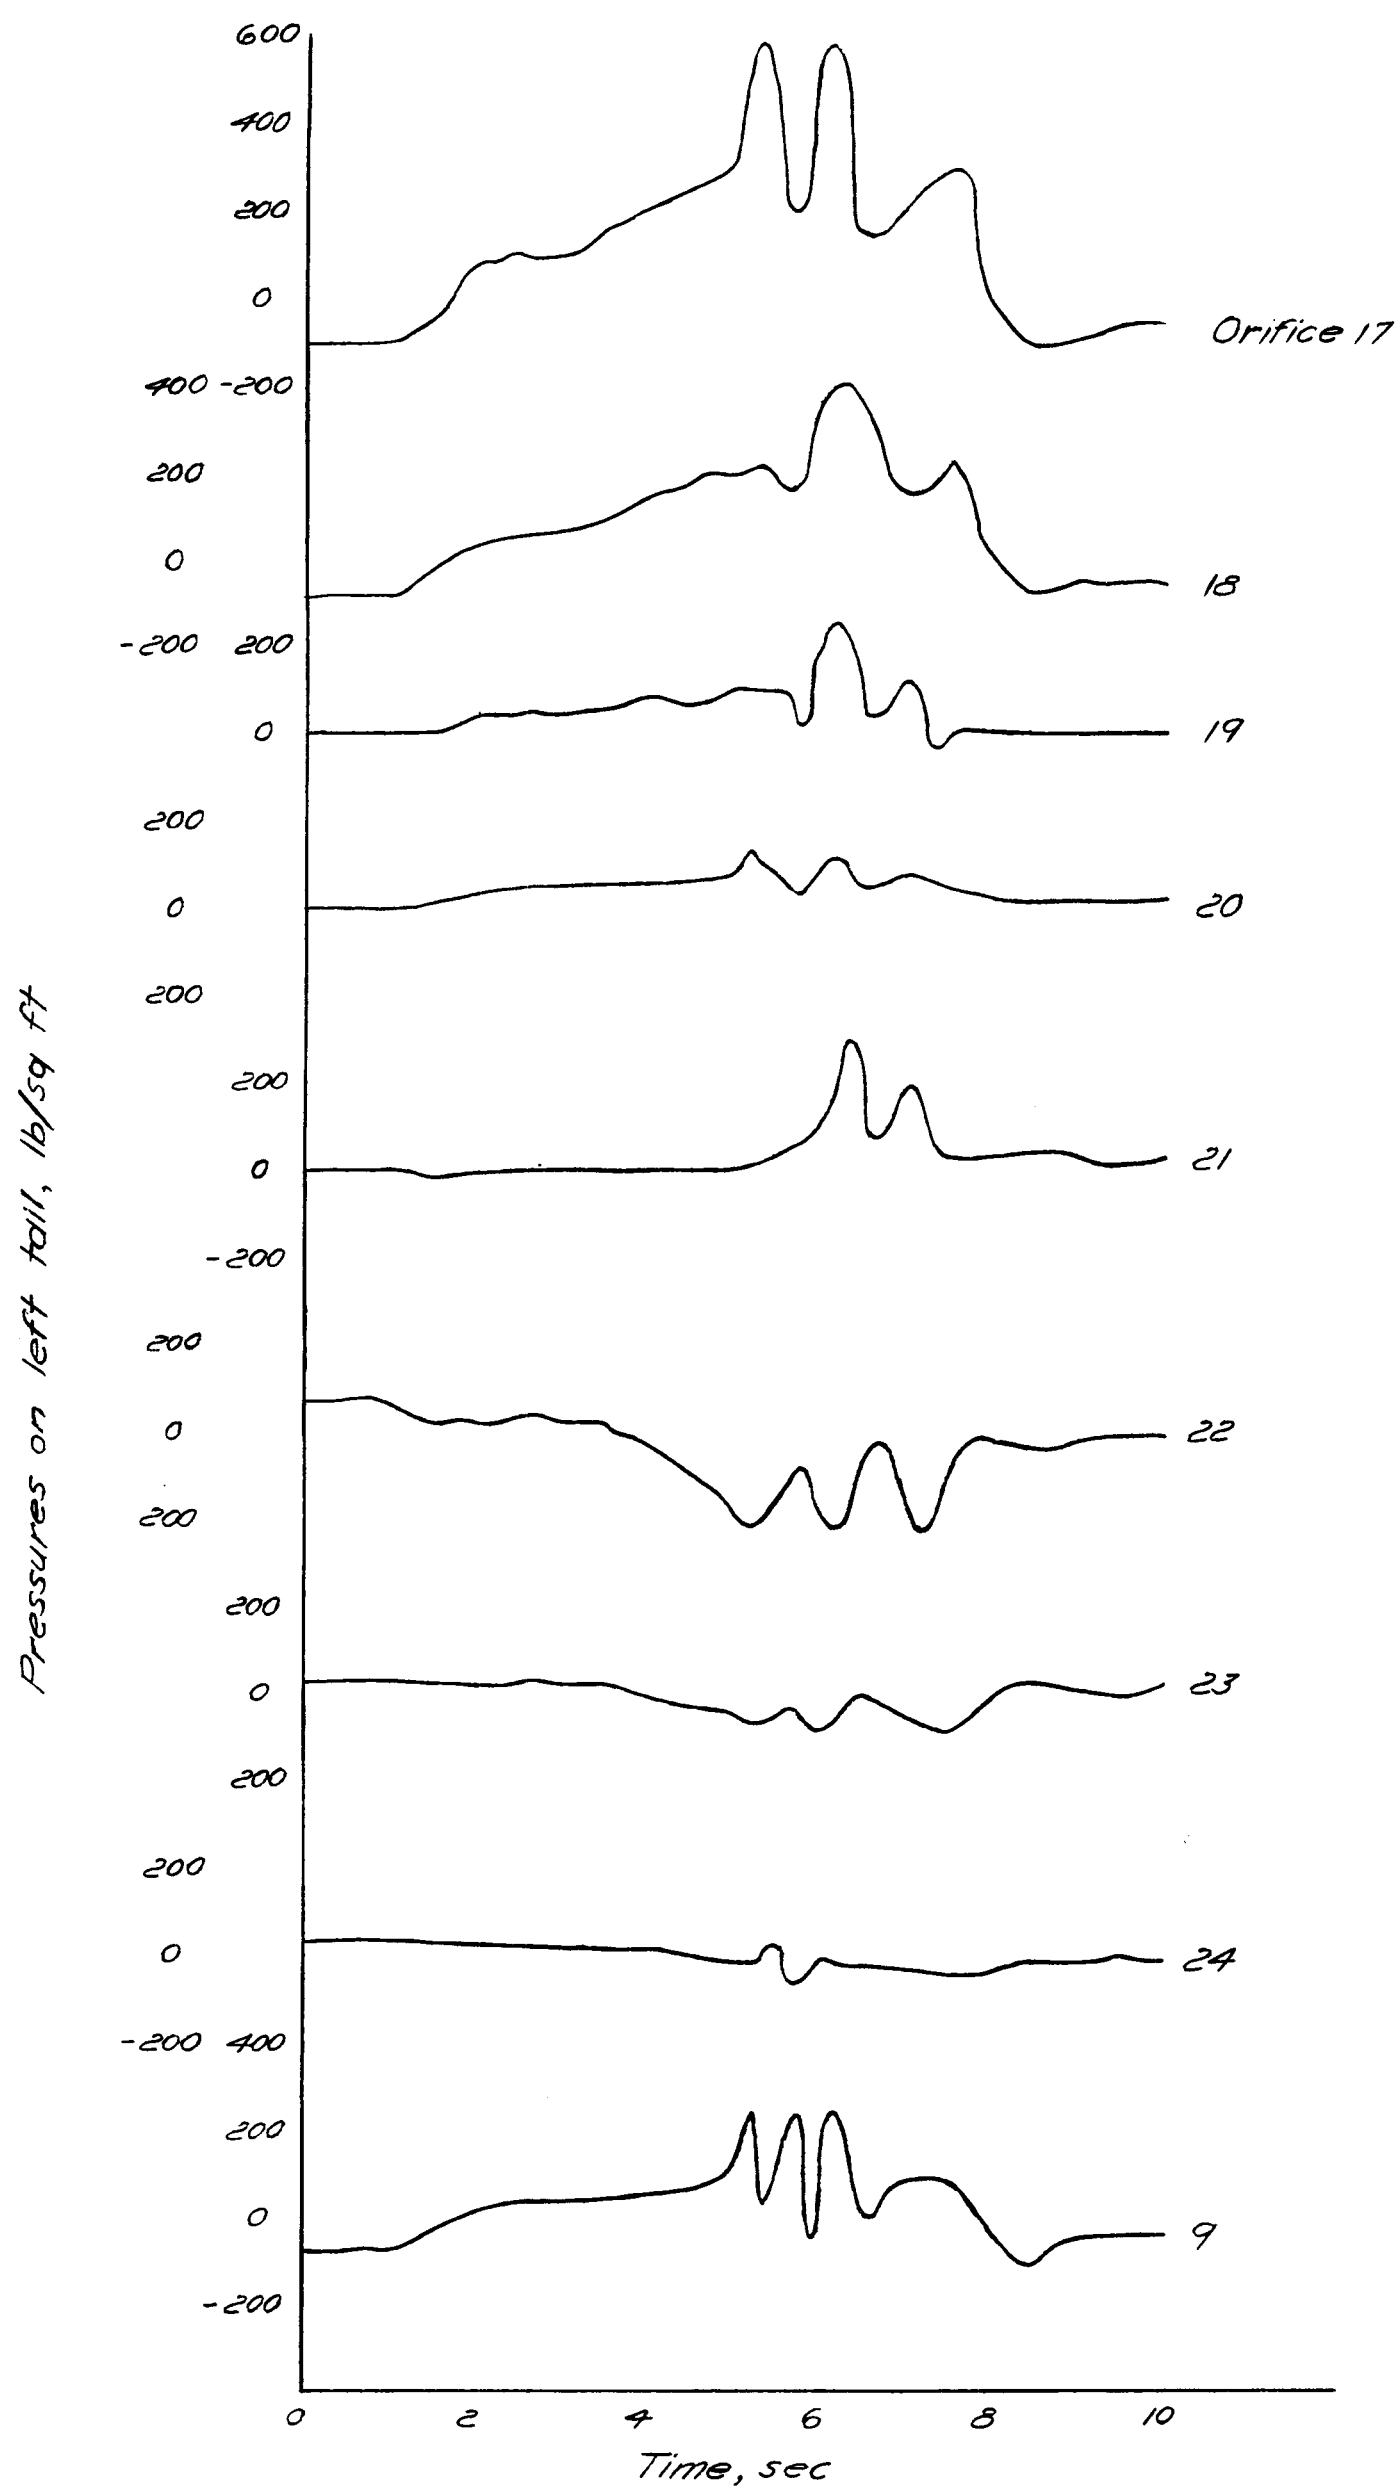
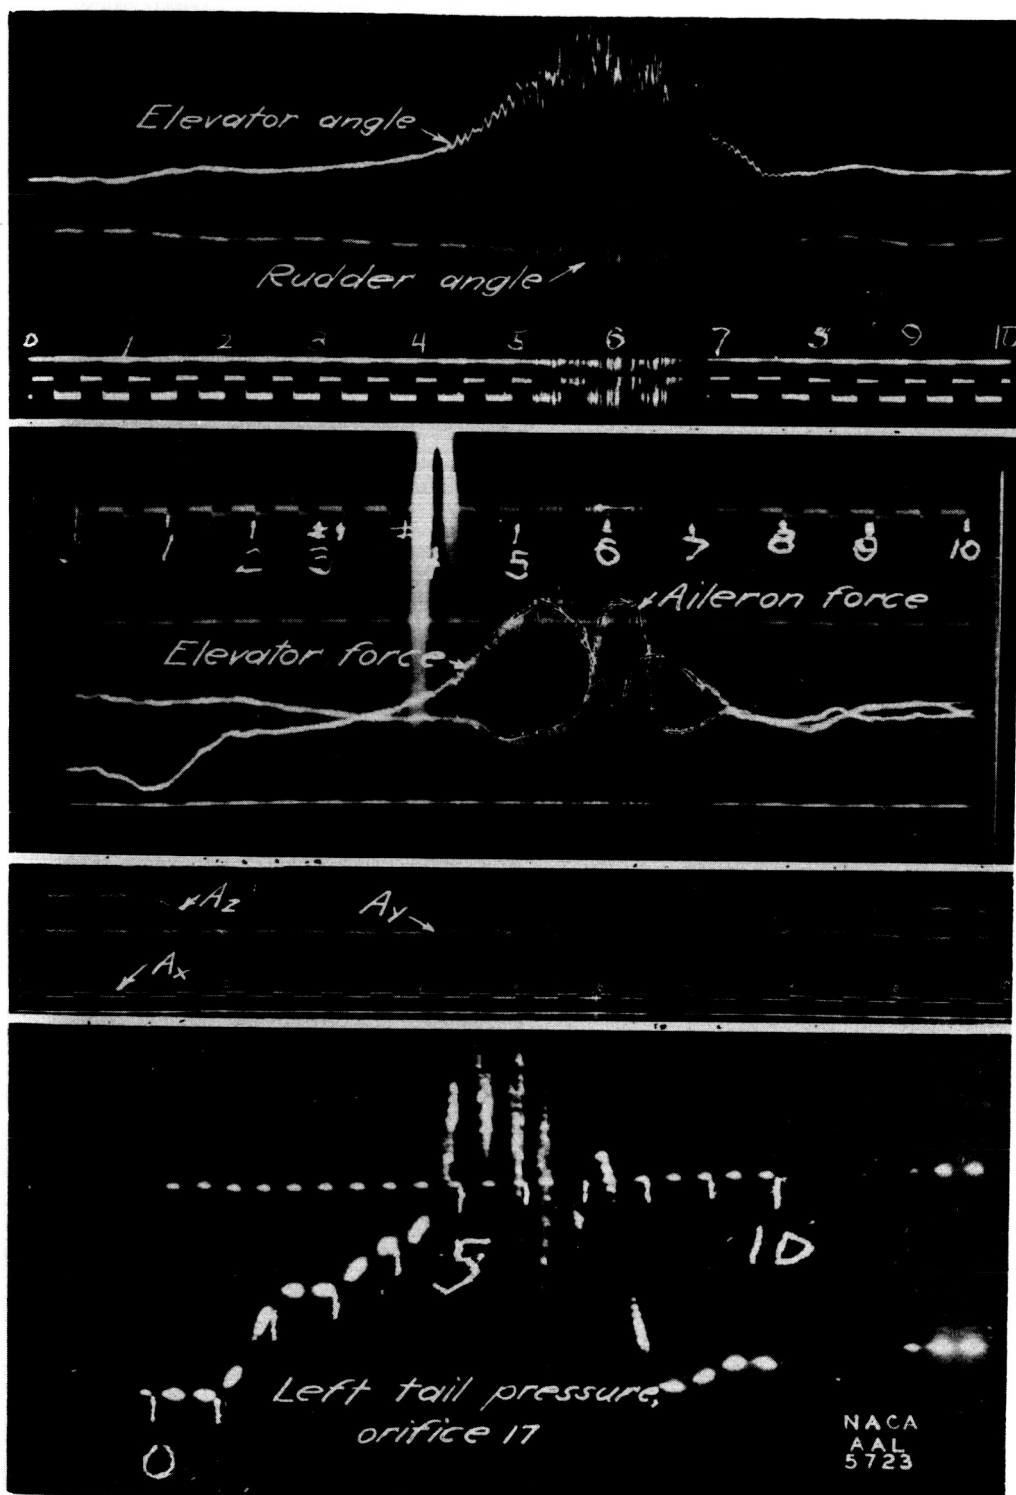
In figures 13, 14, and 15 it is seen that the airplane was ~~pulled in~~ until a very violent stall occurred at a lift coefficient of 1.01 and a Mach number of 0.67. The maximum acceleration factor reached was 7.5 at an angle of attack of 19° . The maximum elevator angle used was 11.5° up. The buffeting was apparently about the same on both sides of the tail in this run. Rapid fluctuations of pressure of 300 to 400 pounds per square foot occurred at the leading edge of the stabilizer during the buffeting. The maximum recorded pressures and unit span loads in this run are listed in the following table:

During this run structural failure of the horizontal tail occurred. Since the airplane was operating within maneuvering limits which were considered safe by design specifications in use at the time the airplane was designed, it is of interest to examine the nature of the tail failure in relation to the loads measured, and in relation to the necessity for revision of air load requirements and the manner of specifying safe maneuverability limits to a pilot.

It is difficult to ascertain at just what time in the pull-out the structural failure occurred. Its effect was not noticeable until after steady straight flight had been re-established. Then it was noticed that the longitudinal balance and stability characteristics of the airplane had altered. Figure 13 shows that a sudden decrease of elevator control force occurred at 5.3 seconds while the elevator angle and normal acceleration continued to rise; figure 15 shows a numerical decrease in the elevator load curve at this point also. Again, at 6.2 seconds, as the acceleration is decreasing, there is a sudden increase in elevator control force and recorded elevator angle. It appears, however, that the elevator control at 6.2 seconds may have been applied inadvertently as the ailerons were being deflected to counteract the roll-off occurring during the stall. The lack of effect of the elevator control on the value of the acceleration factor of the airplane was probably due to the stalled attitude of the wing. The increase of acceleration factor at 7.0 seconds, as the elevator control force and elevator angle were decreasing, was probably due to the re-establishment of normal flow over the wing, although the possibility that it was caused by the buckling of the elevator should not be completely discounted.

loads caused much more severe structural strain than the same loads would have caused if applied under static conditions. In the last pull-out, in which the structural failure occurred (figs. 13, 14, and 15), the buffeting was more severe than in any previous maneuver. In this pull-out an attempt had been made to insure absolutely that the maximum acceleration factor possible to attain had been obtained. A strong pull force was exerted on the stick even after heavy buffeting had set in. A slightly greater elevator angle was used than in the previous pull-outs. It should be realized, too, that the loads which were measured during the buffeting condition may actually have been somewhat greater than those recorded, due to lag in the pressure lines.

Figure 13 - Time history of a power-off dive pull-out at $M \approx 0.67$ in which partial failure of the reinforced horizontal tail structure occurred.

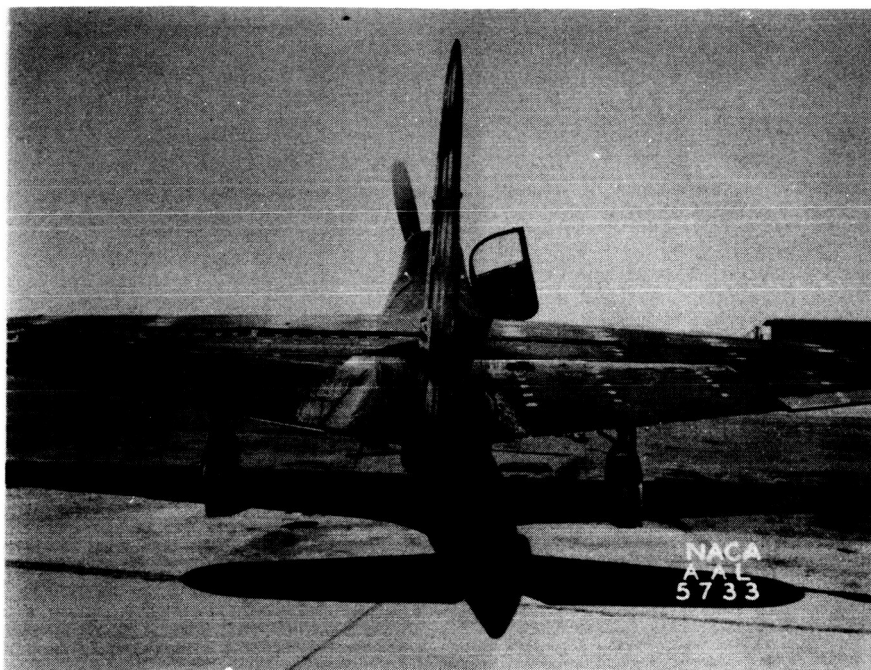
The principal failures were on the left side of the tail, although failure had also started on the right side. A rear view of the airplane with undamaged tail is shown in figure 16, and views of the principal failures are presented in figures 17 to 23. The left elevator had buckled downward at about the third outboard row of orifices (figs. 17, 18, and 19), cracking the elevator spar (fig. 20). The elevator nose balance had been forced downward severely enough to break the elevator nose rib on each side of the tail just inside the outboard hinge fitting (figs. 21 and 22). The left stabilizer rear beam was cracked at the inboard hinge bracket, and the two top bolts holding the bracket to the stabilizer rear beam had been sheared completely (fig. 23). Other miscellaneous failures of various degrees of severity occurred to both the stabilizer and elevator structure in the immediate vicinity of all the hinge brackets.

Figure 17.- Rear view showing damaged horizontal tail surfaces.

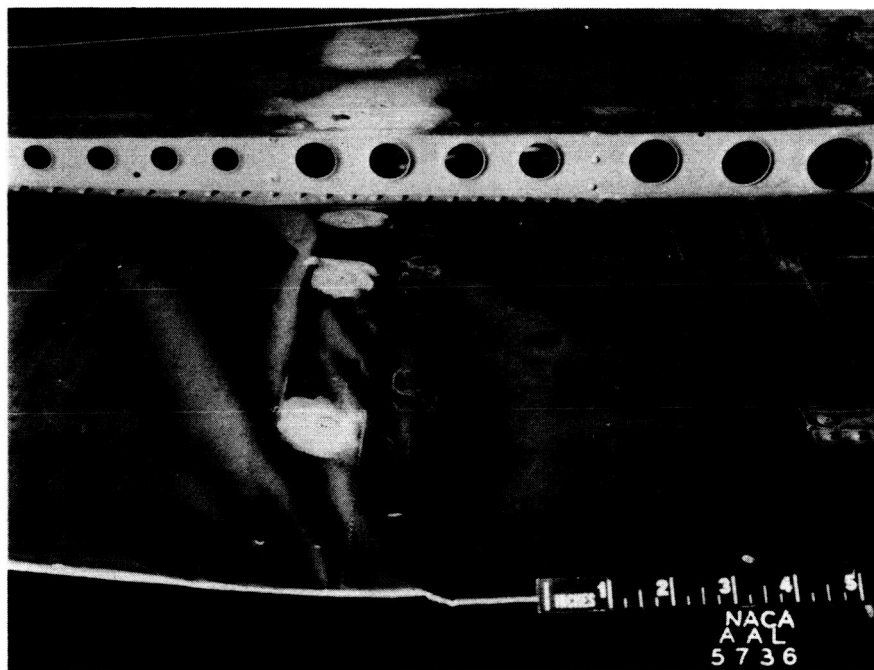
Figure 18.- Rear view of the buckled left elevator.

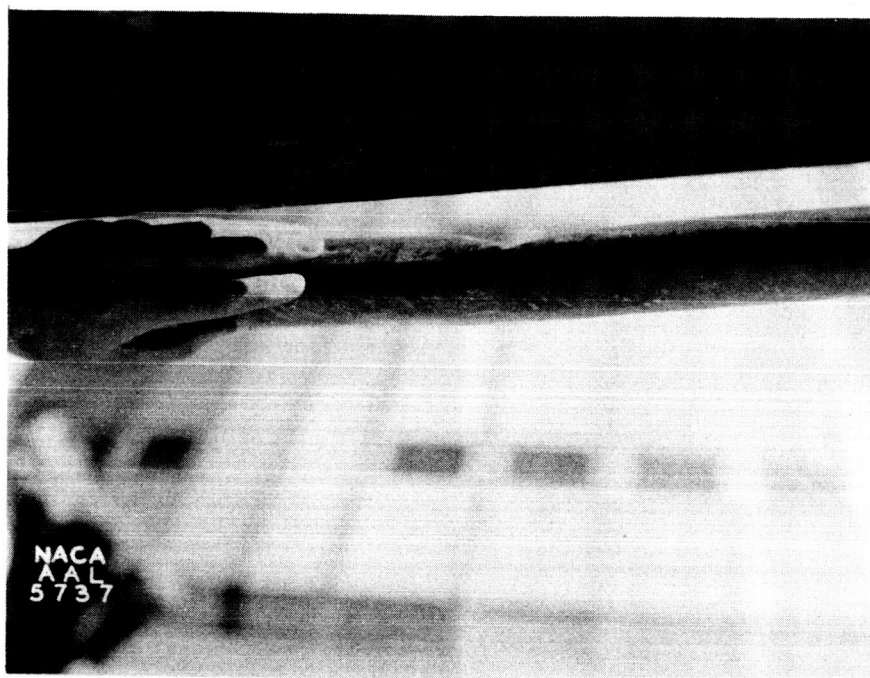
Figure 19.- Lower front view of the buckled left elevator.

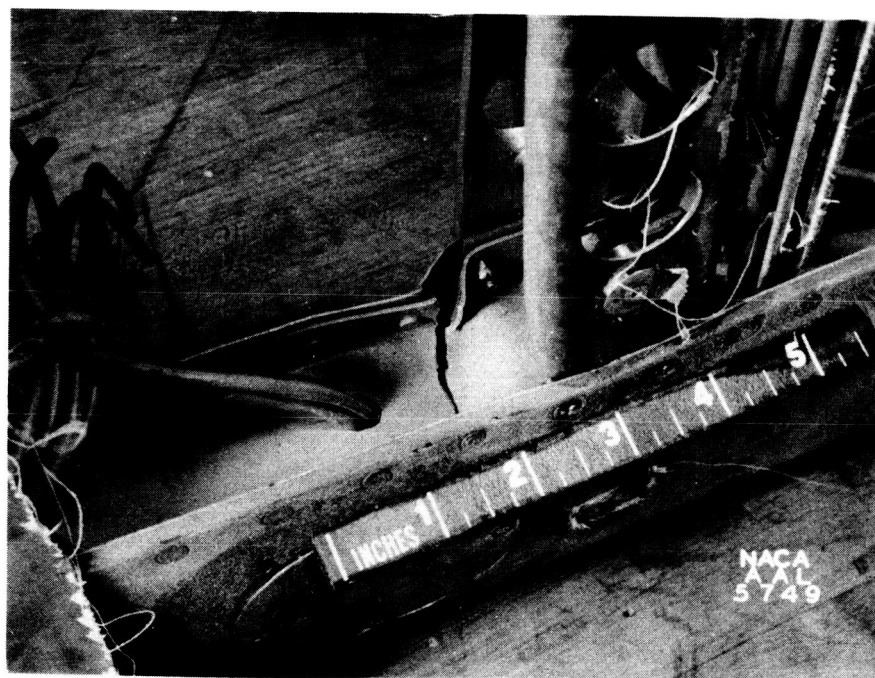
Figure 20.- Detail of cracked elevator spar.

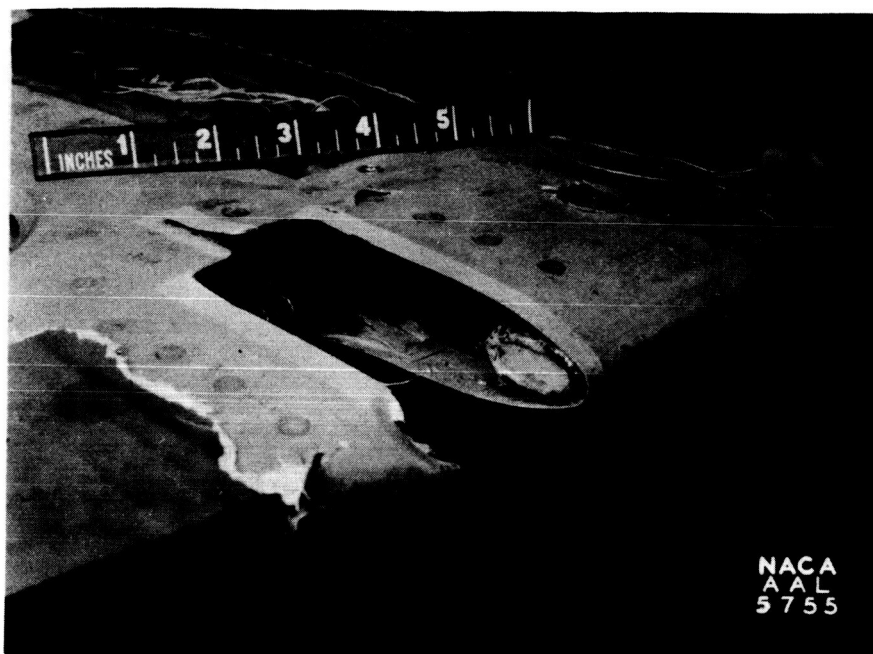
Figure 21.- Lower surface of left elevator showing failure of elevator nose rib at left outboard hinge fitting.

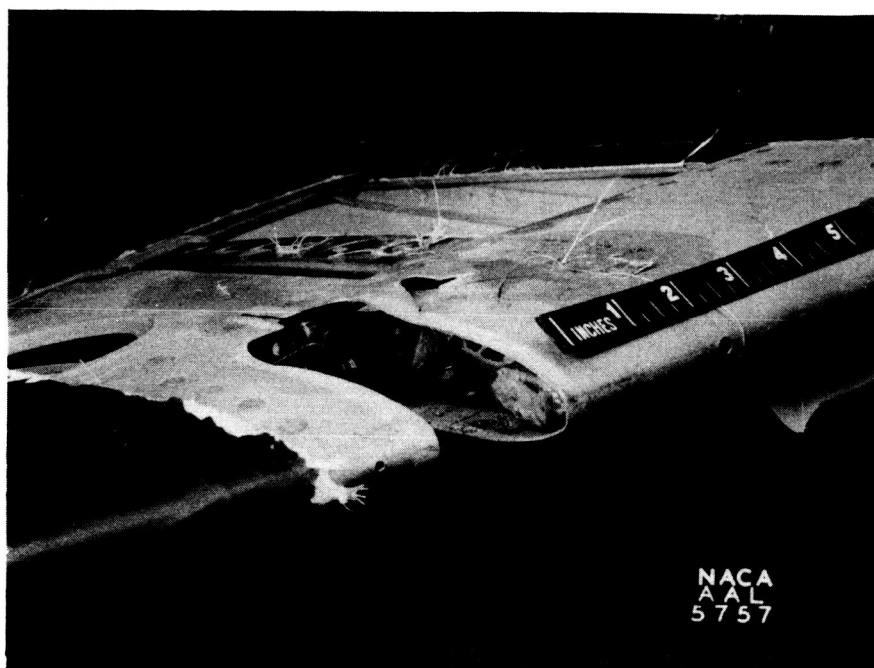
Figure 22.- Upper surface of right elevator showing failure of elevator nose rib at right outboard hinge fitting.

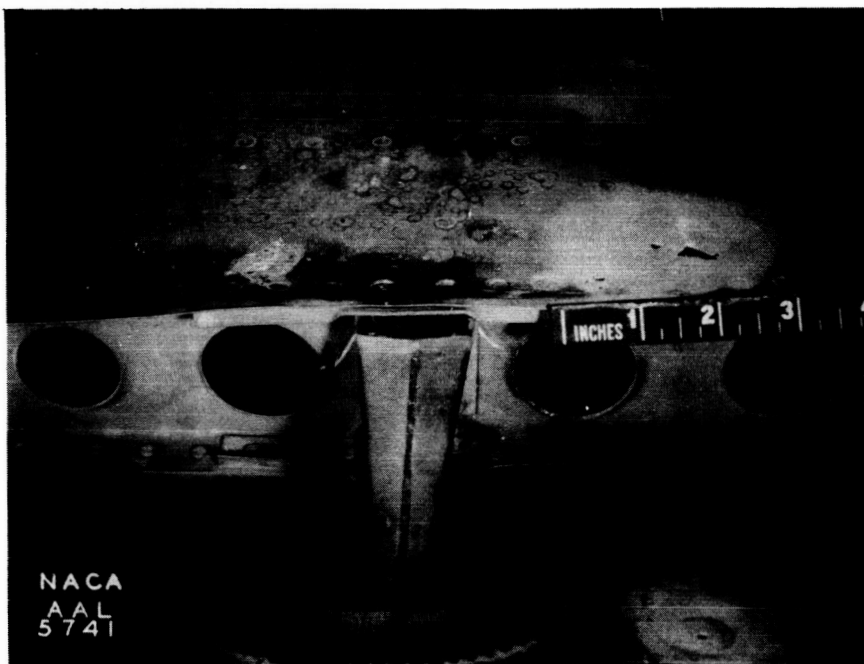
Figure 23.- Detail of cracked stabilizer rear spar at left inboard elevator hinge bracket.

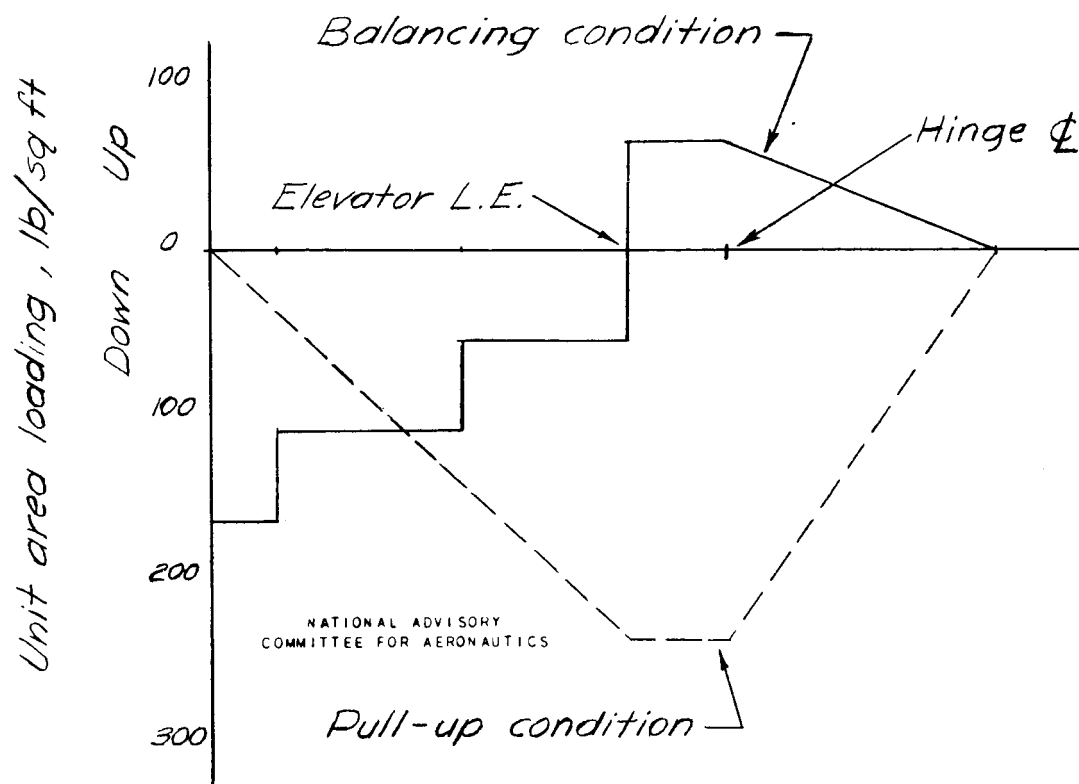
Figure 24 shows the loading conditions for which the horizontal tail surface was designed. Comparison of this figure with the actual flight measurements (figs. 5, 8, 11, and 14) shows that in many instances the unit loads actually measured on the stabilizer in flight were not only considerably in excess of the design unit loads, but that they occurred in a direction opposite to the design loads. At the leading edge of the elevator, the design unit loads were not exceeded in the pull-outs, at least not at the particular spanwise stations at which measurements were made. However, it was the elevator and a fitting supporting the elevator that failed and not the stabilizer.

Figure 24 .— Horizontal tail design load conditions.
